# Aluminum Door Panel Trim Dented by Seat Belt Latchplate

YEAR(S)	MODEL(S)	ADDITIONAL INFORMATION
2013 – 2014	GS350

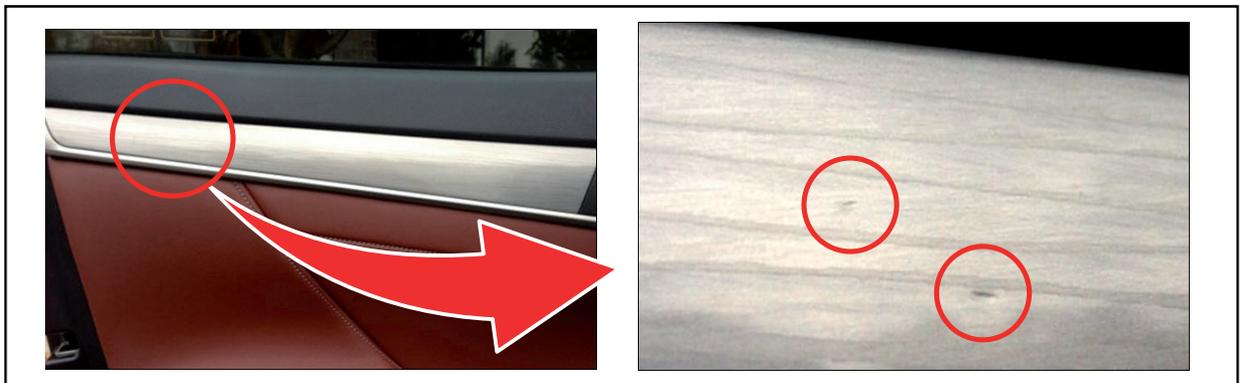
**Figure 1.**

Some 2013 – 2014 model year GS 350 vehicles may exhibit a condition where the door trim becomes dented during normal use (such as contact with the seat belt latchplate tang during retraction). The Front Door Trim Ornament has been updated to address this condition.

1. Confirm the condition as described in the Introduction.

2. Remove and replace the Front Door Trim Ornament.
